Manhole Inspection Summary

Manhole # S45I__065MH

Insp Date: **4/24/08 2:04 PM**

Location Address: **1901 gough st**

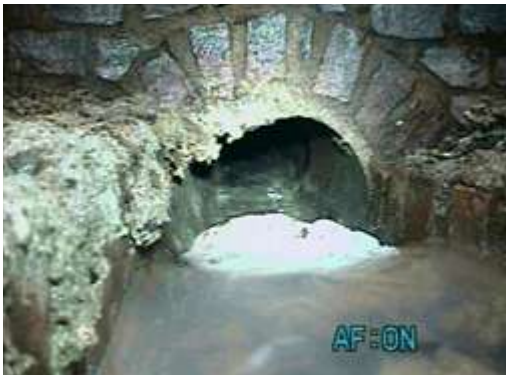
Defect 3

Condition: ☐ Sound ☐ Cracked ☐ Root Intrusion ☐ Deteriorated ☐ Leaks ☒ **Debris**

channel and bench debris

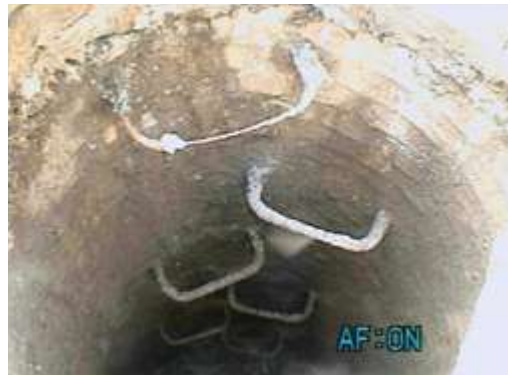
Defect 2

Infiltration: ☐ None ☒ **Joint** ☐ Cracks ☐ Mortar ☐ Roots ☐ Wall

Count: **6** Missing: **0** ☒ **Corroded**

corroded stairs, infiltration from chimney joint

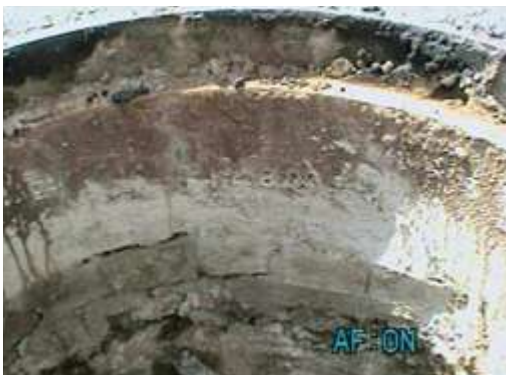
Defect 1

Condition: ☐ Sound ☐ Cracked ☐ Root Intrusion ☐ Loose Brick ☒ **Deteriorated**

Chimney deteriorated, frame adjustment
